Department of Administration
Construction Update No. 48
February 22, 2005

Repair Work to Begin Soon on the Terra Cotta Dome

Contractor Making Progress on Masonry Repairs

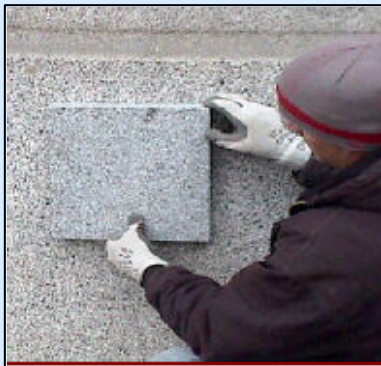
As part of the masonry restoration work, any refinished or replacement sandstone or granite must match the Capitol's existing exterior. **Pictures show** masonry workers comparing samples of new and refinished stones at different elevations of the building.
